Placencia Mooring Masters

Icranmar – Conservation In Action
Placencia Mooring Buoy Project

Supporting the Implementation of Voluntary Standards for Recreational Boat Operations through the Improvement of the Existing Marine Infrastructure of the Roatan Marine Park

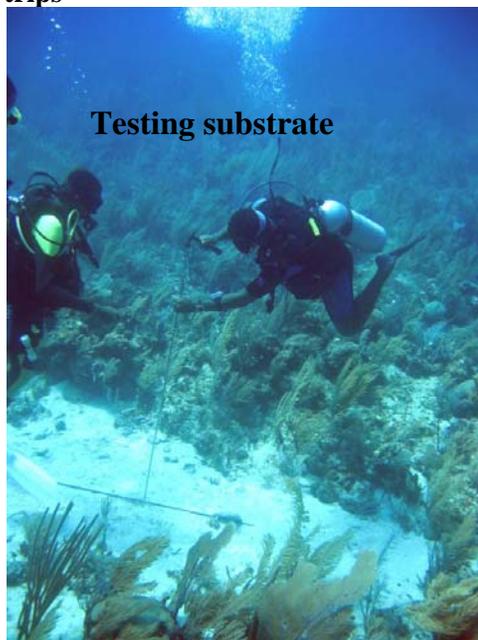
Suitable spots at different locations were marked with flags & notes were taken on PVC slate.

Testing substrate

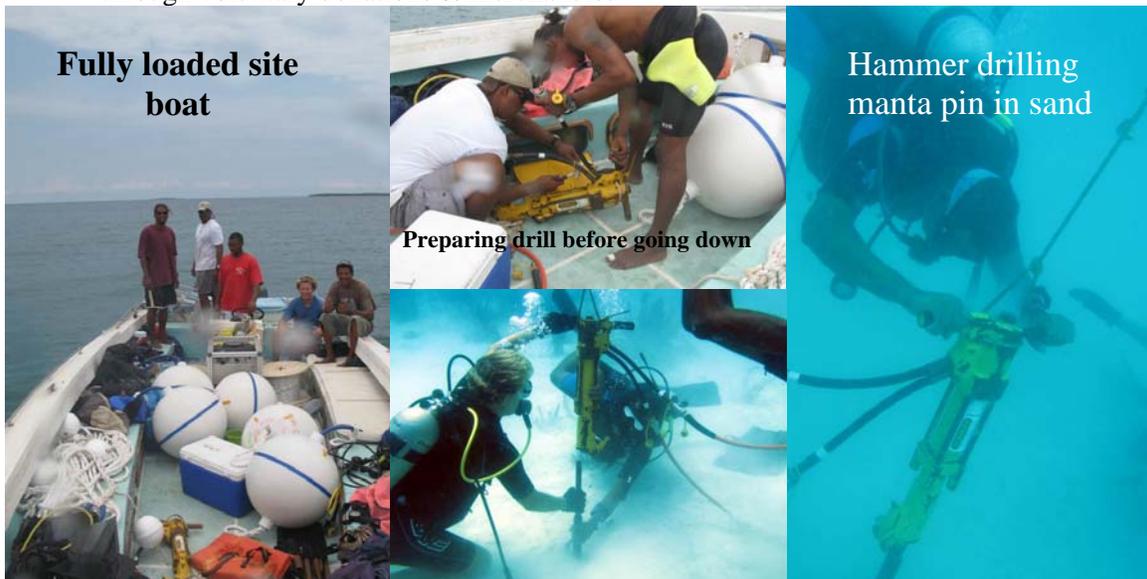
First we installed the Manta Rays inside in shallower waters to practice & teach.

- Purchase mooring hardware from EMI – “Environmental Moorings International” who specialize in this. We bought 17 “Manta Rays” which jack-hammer into the sandy locations with at least 7ft. of sand. Two eye bolts will be cemented in 2” holes drilled in hard bottoms with chain joining them together for a stronger mooring in deeper water. We chose 24” buoys for deep scuba sites & 18” buoys for anchorages.
- Enlist the Belize Tourism Board’s (BTB) assistance in clearing the equipment duty free through Belize Customs.
- Host classes on splicing rope to teach as many people in the community how to assemble the top side buoys & make up the pickup lines.

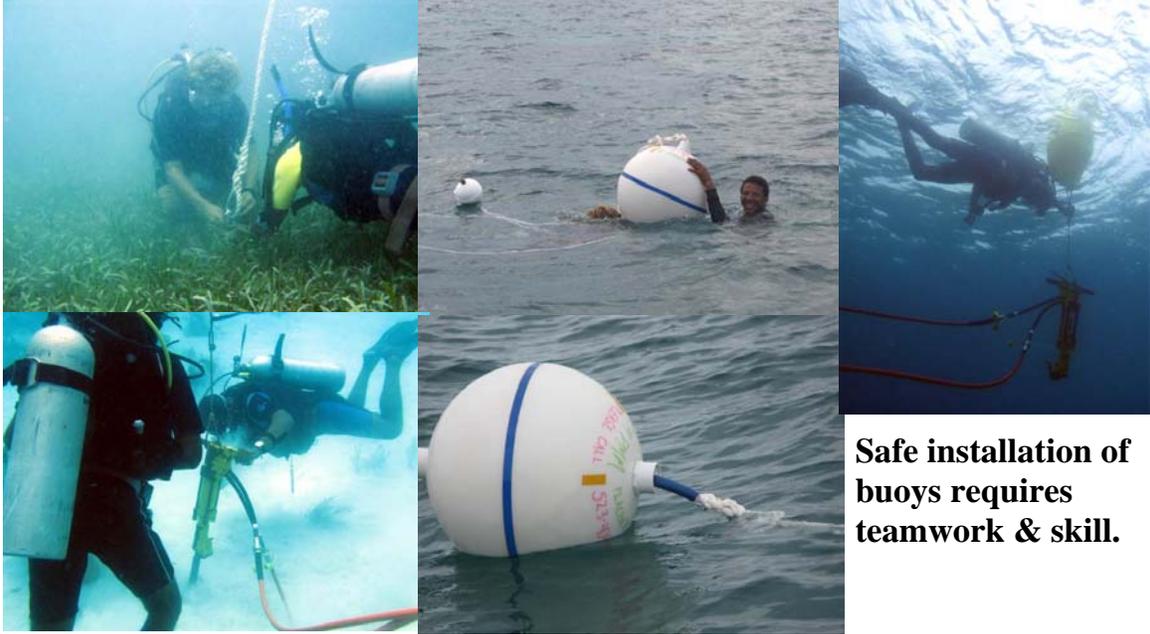
Safe installation of buoys requires teamwork & skill.
